MTL TR 88-4

BALLISTIC COMPRESSOR EXAMINATION OF ELECTRODEPOSITED NIOBIUM

March 1988

US ARMY
LABORATORY COMMAND
MATERIALS TECHNOLOGY
LABORATORY

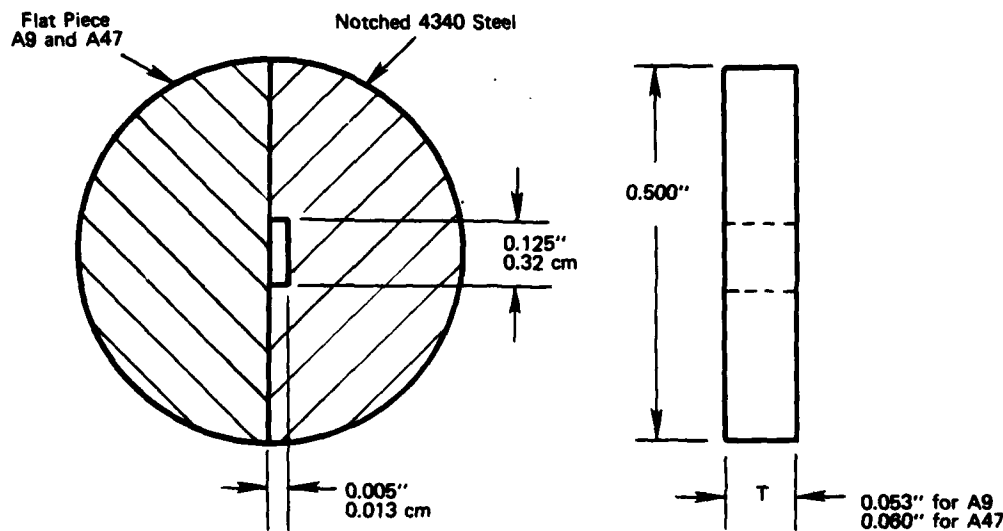
Figure 1. Sample dimensions, showing the narrow erosion/corrosion channel milled in one of the two pieces which make up the disk.

The MTL ballistic compressor attains gas pressures of the order of 2000 atmospheres and temperatures of the order of 5000 Kelvins. In order to obtain high heat transfer and shearing wipe off conditions simulating those which might occur in a gun tube or rocket nozzle, the hot gases were constrained to flow through a channel about 130 micrometers thick by 3.2 mm wide for a length of about 1.5 mm. One side of this channel consisted of the niobium-plated "test" specimen. Unfortunately it was not feasible to construct the other side of the channel of the same material; instead 4340 steel was used, as sketched in Figure 1.

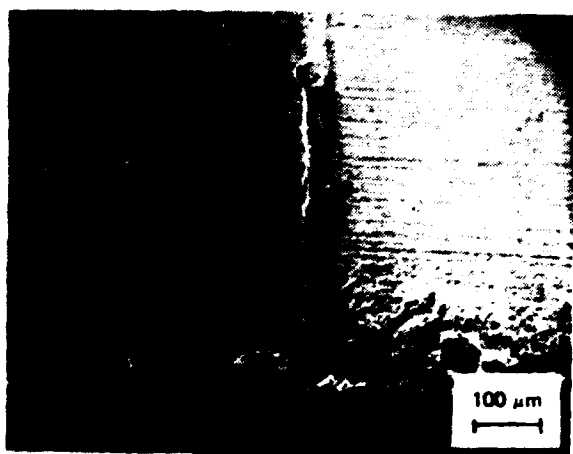
Micrograph 1 Mag. 75X

Figure 5. SEM micrographs of niobium-coated sample A47. Direction of gas flow is from bottom to top.

The single shot on A47 yielded more visible discoloration than did the totality of shots on A9. This effect is also seen in micrograph 1 which shows the interface between the damaged and undamaged regions of the sample. (The damaged region, which appears light and is on the right of the micrograph, is that which appears discolored to the naked eye.) The explanation is offered by micrographs 2 and 4, which show this interface at higher magnification. Note that the damage (on the right side) is not sufficient to obliterate the polishing marks, but that the surface is noticeably disturbed. This disturbance is also shown in micrograph 5 where the leading edge is noticeably more swirled than is the trailing edge. Thus, we note that the swirling is more conspicuous at the leading edge and along the boundaries of the channel than it is in the central and trailing portions of the channel. Although some damage was evident, to a greater or lesser degree, everywhere on the exposed surface, no cracking of the niobium was observed.

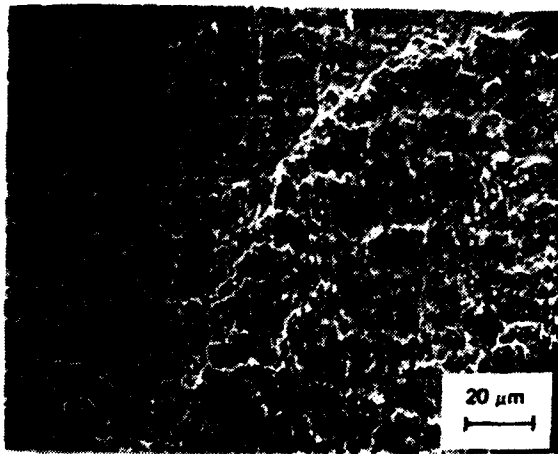
Micrograph 10 Mag. 375X

Figure 6. SEM micrographs of niobium-coated sample A9. Direction of gas flow is from bottom to top.

greatest in A47. On the other hand, in the central portion (represented by the upper right hand portion of micrograph 11) where the swirling is greatest in A9, this swirling is more evident, even at Mag. 100X, than is the swirling in micrograph 1. This general behavior, that the entrance surface of A47 resembles the exit region of A9, is confirmed by micrograph 10. Here we see an appearance more like micrograph 4 (of the leading edge) than like micrograph 2 (of the trailing edge). Note that the region of reduced swirling (on the left in micrograph 10) is still well within the boundaries of the channel.
